Manhole Inspection Summary

Manhole # S17G__039MH

Insp Date: **10/5/07 1:26 PM**

Location Address: **1 GORMAN-BENTALOU**

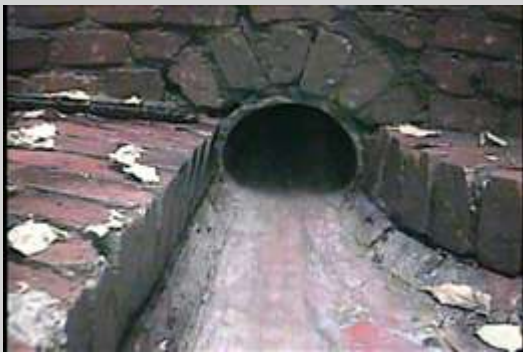
12 O'Clock Outflow

Pipe Height: **8.4** (in.) Rod and Bar (Angled)
Pipe Material: **Clay** ☐ Pipe Lined
Invert Depth: **7.74** (ft.) Flow Characteristics: **Fast**
Deposits: ☒ None ☐ Mud ☐ Sludge ☐ Debris ☐ Grease
Silt Depth: (in.) Deposits Extent:
Infiltration: **None** Pipe Seal Cond: **Sound**

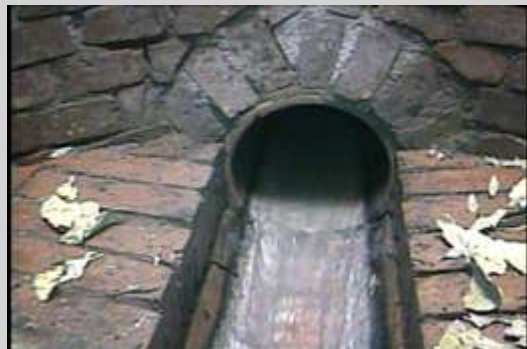
6 O'Clock Inflow

Pipe Height: **7.2** (in.) Rod and Bar (Angled)

Pipe Material: **Clay** ☐ Pipe Lined

Infiltration: **None** Pipe Seal Cond: **Sound**
